## ONX-W09\_SectionA-A\_newholes.pdf

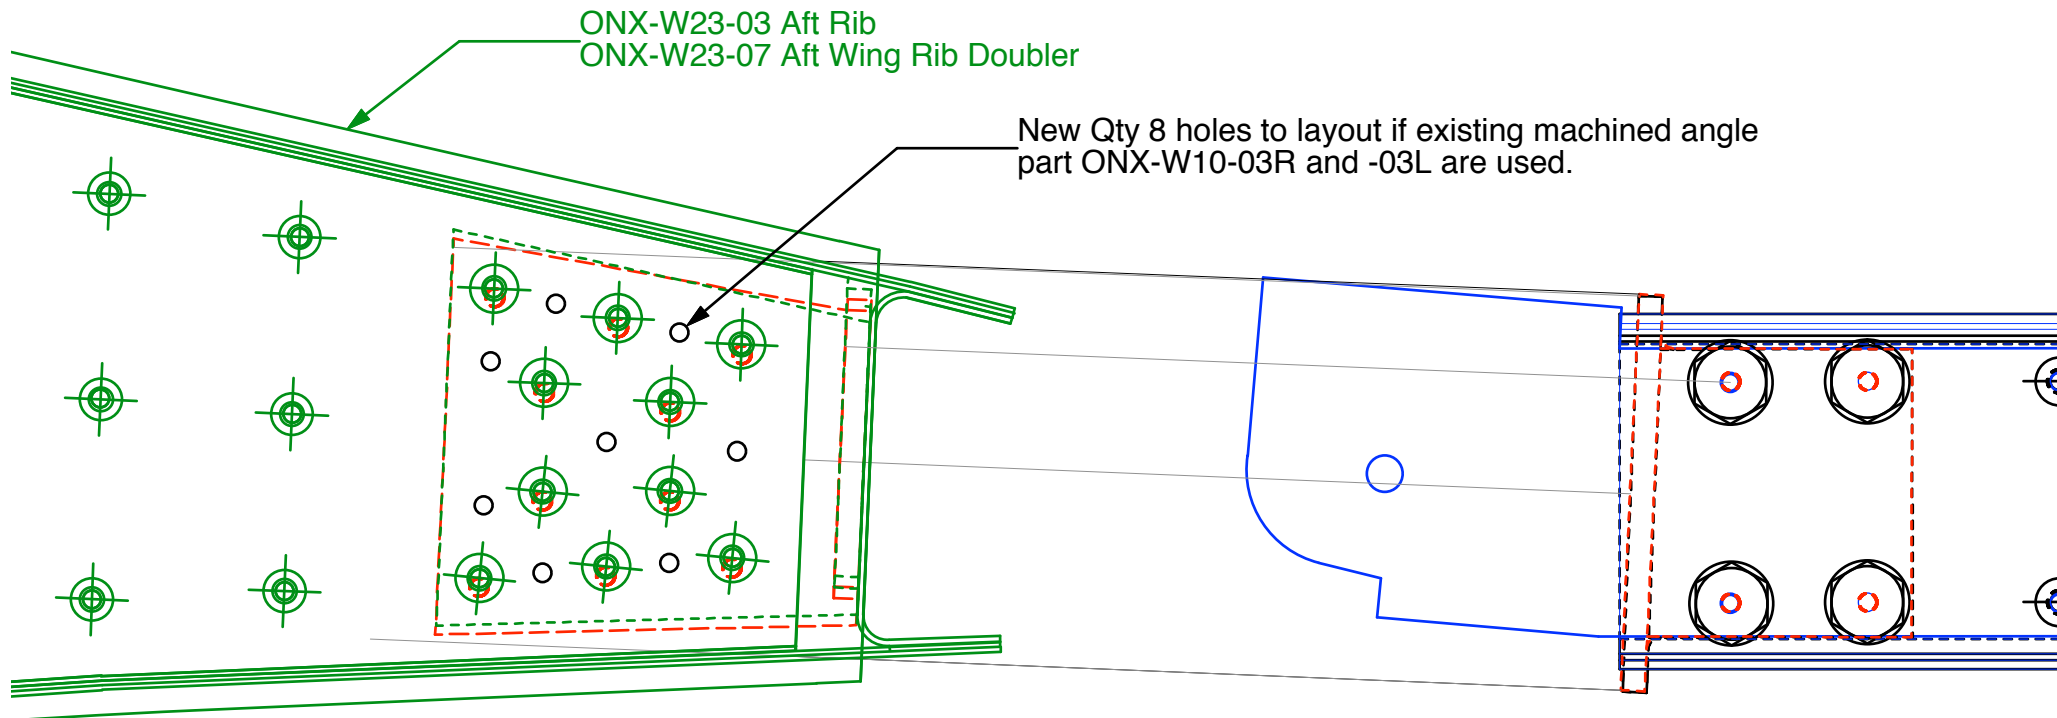
ONX-W09 Section A-A (Rib #6) in Green.  
ONX-W10-03R Part in Red  
Incorrect hole alignment shown with green holes not aligning with red holes.

ONX-W10-01R Assembly in Blue.  
ONX-W10-03R Part in Red  
This assembly is correct

This detail shows the new hole layout to put through ONX-W23-03R/L, ONX-W23-07, and ONX-W10-03R/L to achieve correct alignment between joint rib and the rear spar. Qty 8 new hole layout is in black.

Other option is to remake the ONX-W10-03R and -03L per the detail provided on print ONX-W10 and leave out the interfacing holes with the aft rib and aft rib doubler.
