Status: MANDATORY

Models and Serial Numbers: Jabiru 3300 Tri Gear Configurations

Reference Number: SNX-SB-007

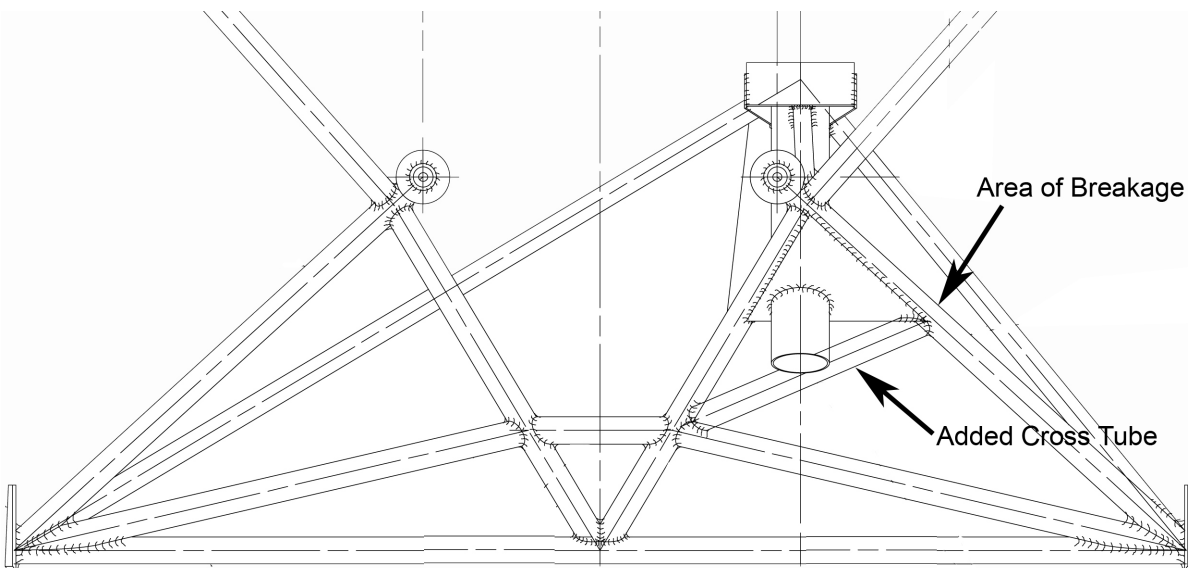
Sonex Aircraft has received reports of the tri-gear Jabiru 3300 engine mounts breaking where the outer tube interfaces with the triangular bracket that supports the nose gear strut.

Sonex Aircraft has upgraded all new production Tri-Gear Jabiru 3300 motor mounts (identified on the plans, on packing lists, and by part label as part number SNX-P22-10) to include an additional tube. This tube, made of 3/4" diameter x .035" wall 4130 steel tubing can be added to all existing motor mounts.

Registered Sonex aircraft owners can contact Sonex Aircraft at tech@sonexaircraft.com and request a free tube, part number SNX-P22-07, which can be welded to your motor mount after removing the engine.

The tube must be welded in place using accepted aircraft welding and repair practices.
